**Title 5 Official Inspection Form**

Subsurface Sewage Disposal System Form - Not for Voluntary Assessments

#7 Allen St Edgartown Map 6 Lot 22.4

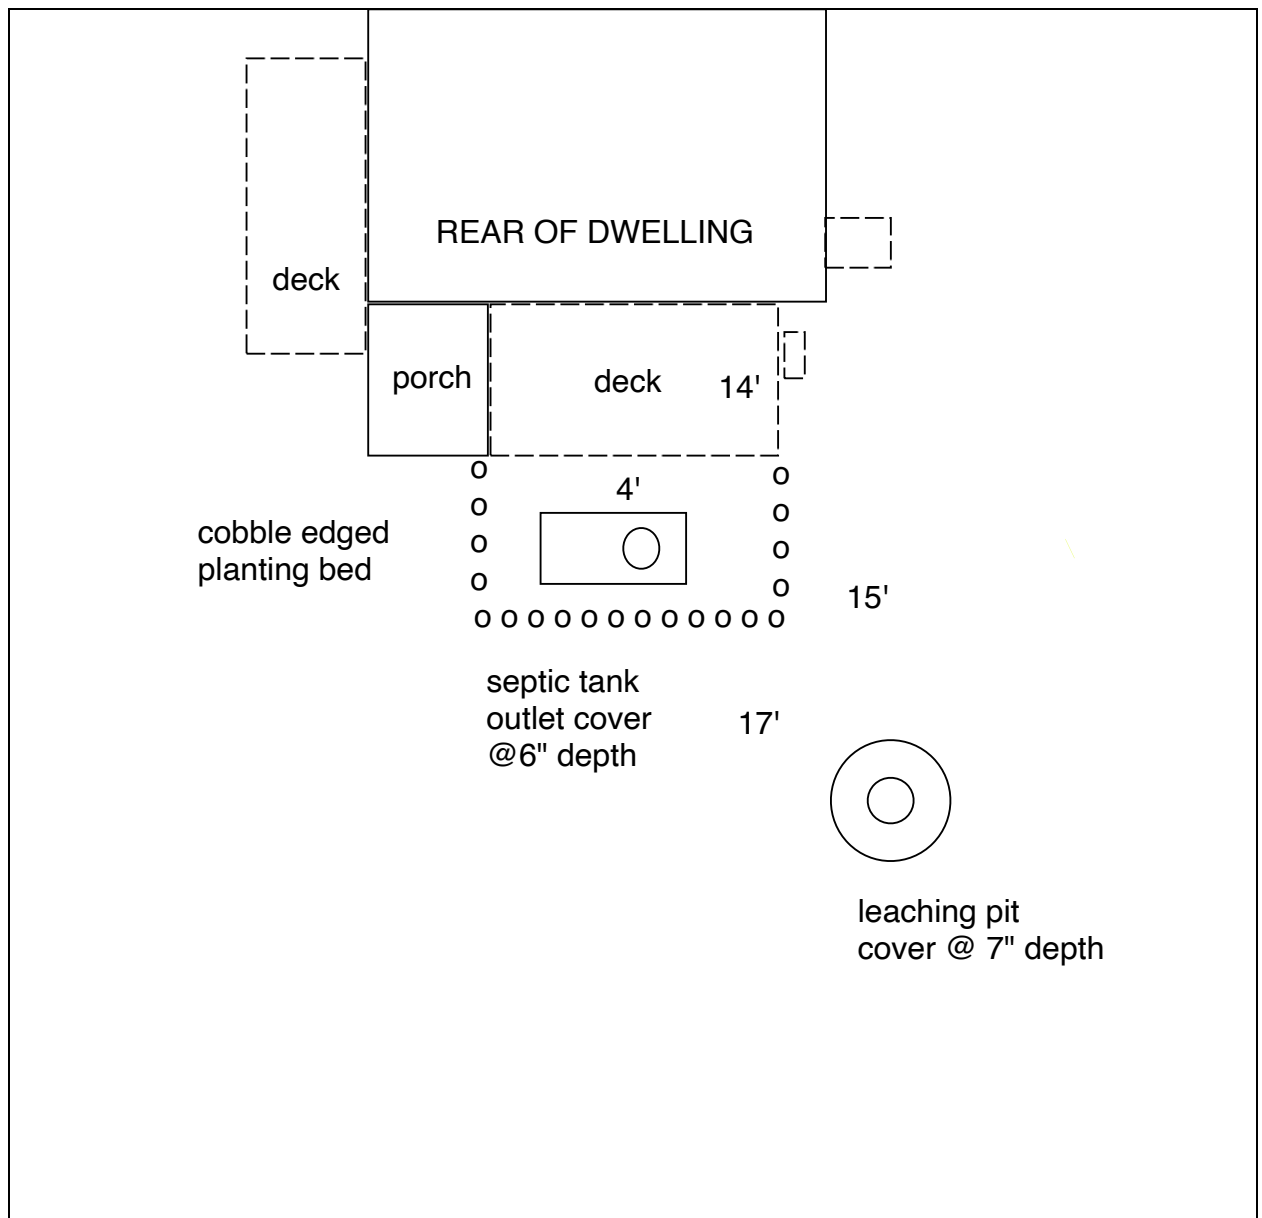
Provide a view of the sewage disposal system, including ties to at least two permanent reference landmarks or benchmarks. Locate all wells within 100 feet. Locate where public water supply enters the building. Check one of the boxes below:
