Title 5 Official Inspection Form

Subsurface Sewage Disposal System Form - Not for Voluntary Assessments

#5 Stillpoint Meadows Rd West Tisbury Map 22 Lot 4.1

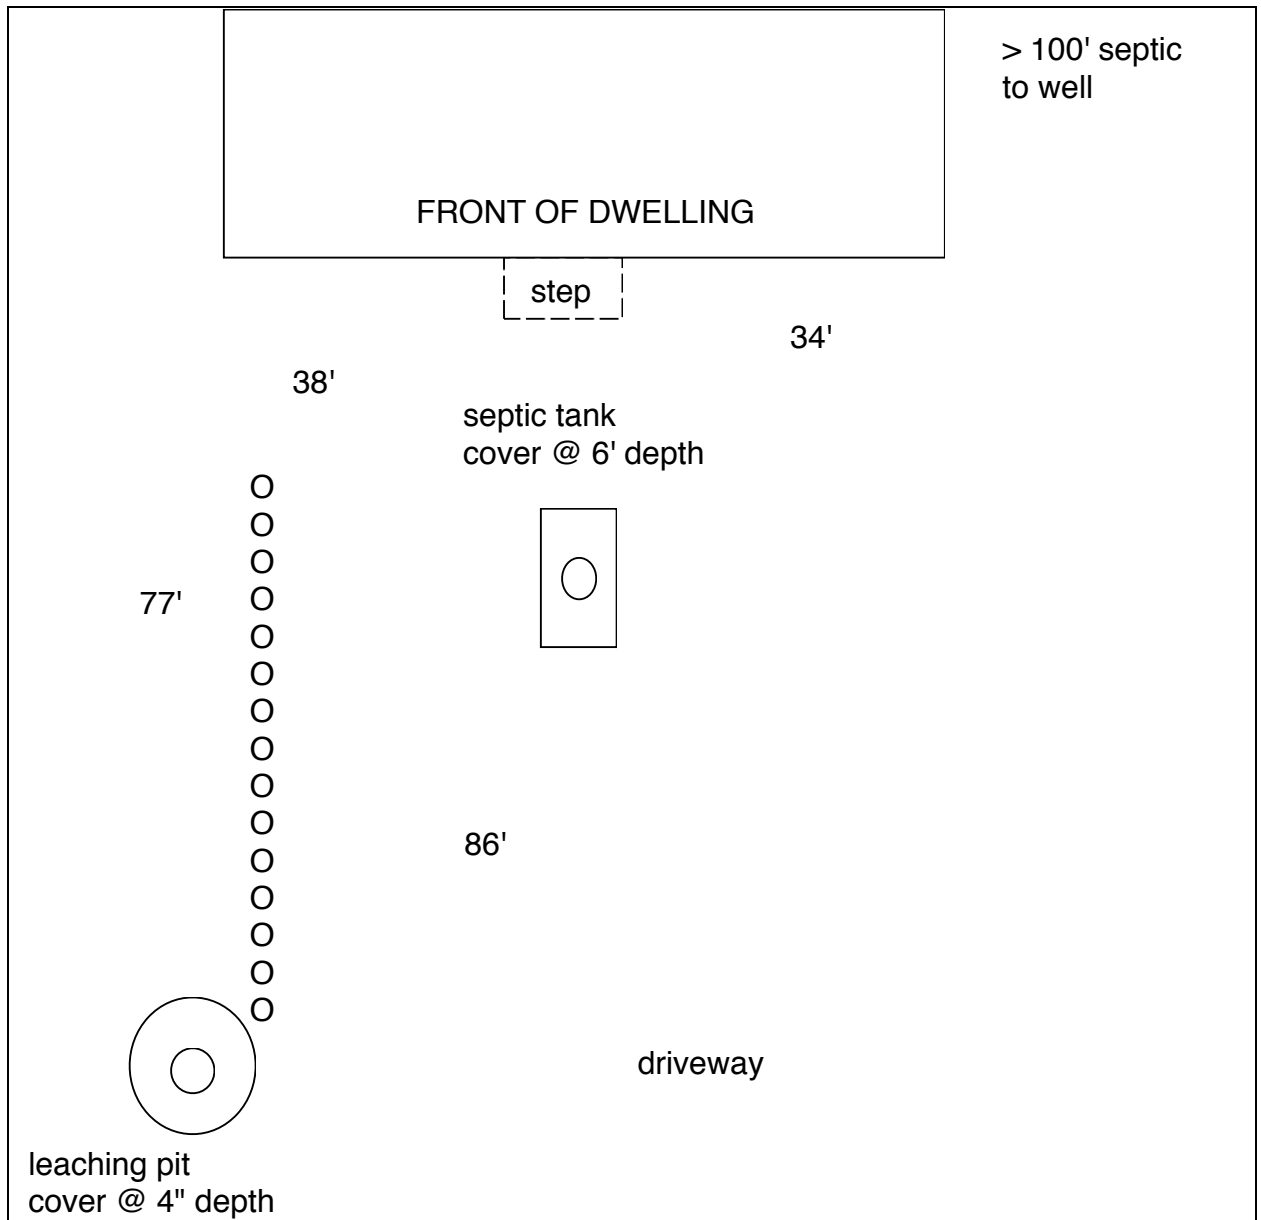
Provide a view of the sewage disposal system, including ties to at least two permanent reference landmarks or benchmarks. Locate all wells within 100 feet. Locate where public water supply enters the building. Check one of the boxes below:
